**REMOVAL PROGRAM
PRELIMINARY ASSESSMENT/
SITE INVESTIGATION REPORT
FOR THE
JARD COMPANY INC. SITE
BENNINGTON, BENNINGTON COUNTY, VERMONT
13 AND 14 JUNE 2006**

Weston Solutions, Inc.
Region I
Superfund Technical Assessment and Response Team III (START)
3 Riverside Drive
Andover, MA 01810

August 2006

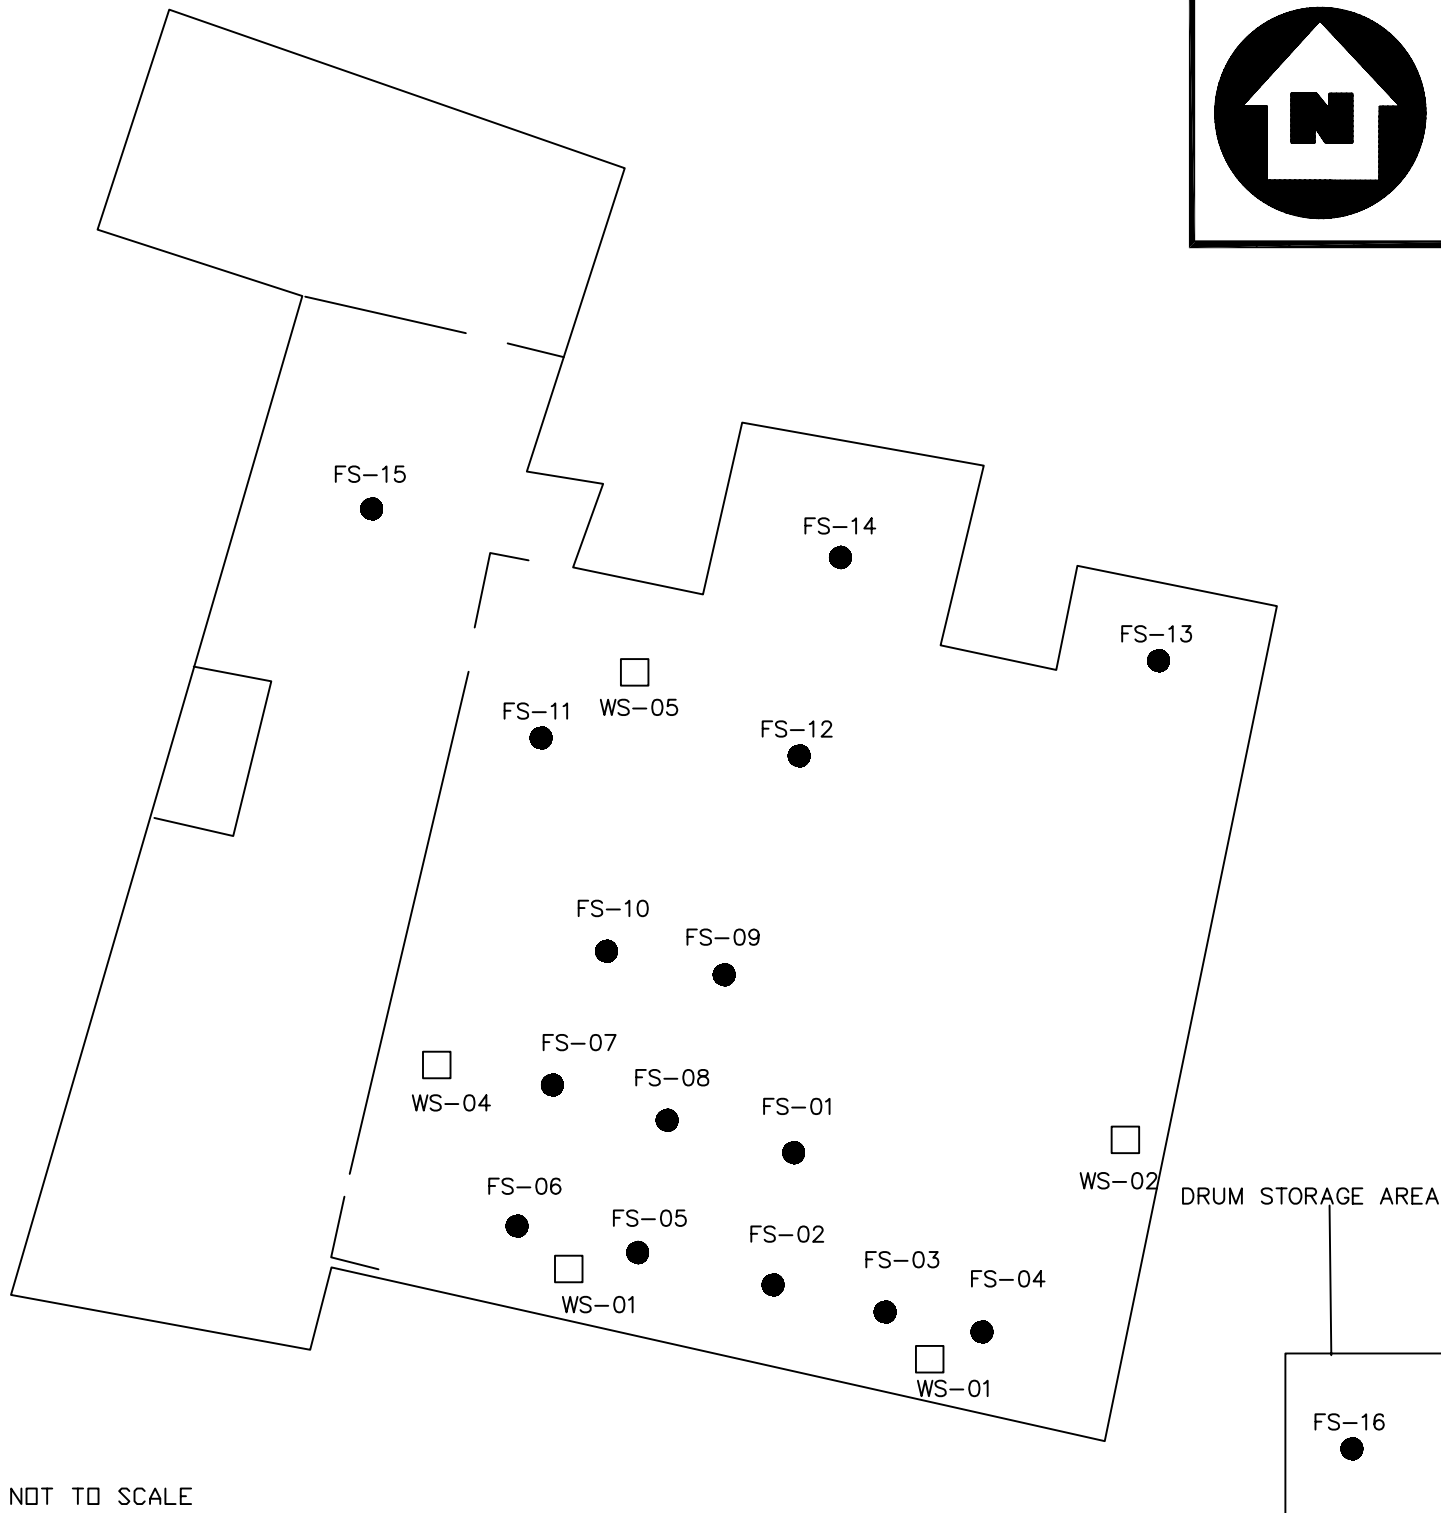
Page 22 of 57
FIGURE 3

- CONCRETE FLOOR SAMPLE LOCATION (NOTE: COLLECTED FROM 6 INCHES BELOW THE FLOOR USING A DRILL)
- WIPE SAMPLE LOCATION (NOTE: COLLECTED FROM 2 FEET ABOVE THE FLOOR ON THE WALL)

SAMPLE LOCATION MAP (INTERIOR)

map created by VT DEC contractor, Stone. [See Appendix A – Figure 3 - Sample Location Map (Interior).] START members Mace and Shelat conducted a reconnaissance of the exterior of the building to establish the surface soil and subsurface soil sample locations using the Global Positioning System (GPS) Waypoint Navigation feature and using the GPS locations documented by Stone during the August 2005 sampling event. [See Appendix A – Figure 3A - Sample Location Map (Exterior).]

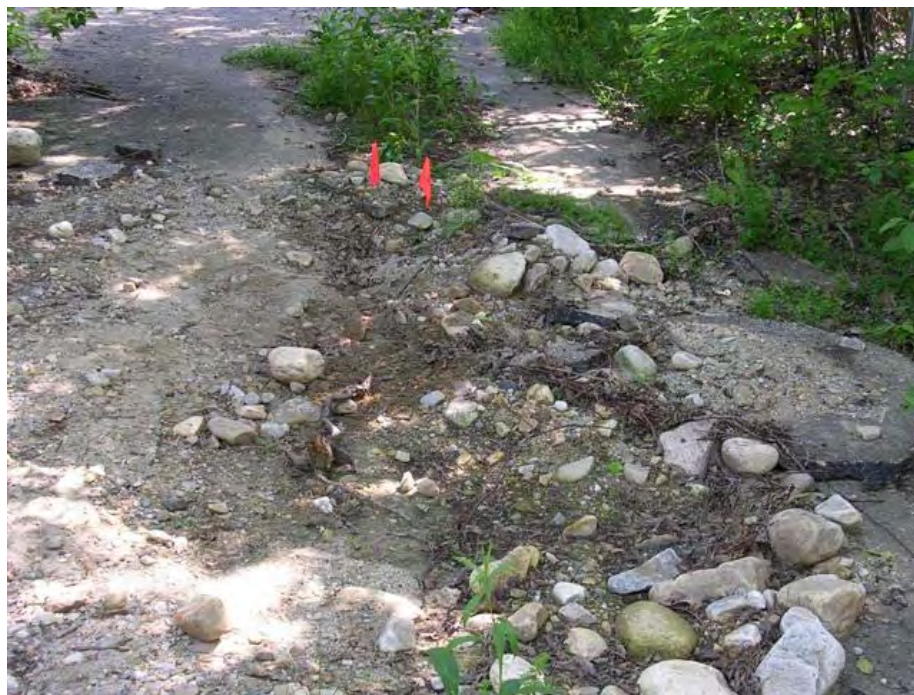
SCENE: View of surface and subsurface soil sample location SS/SB-01. Photograph taken facing south.

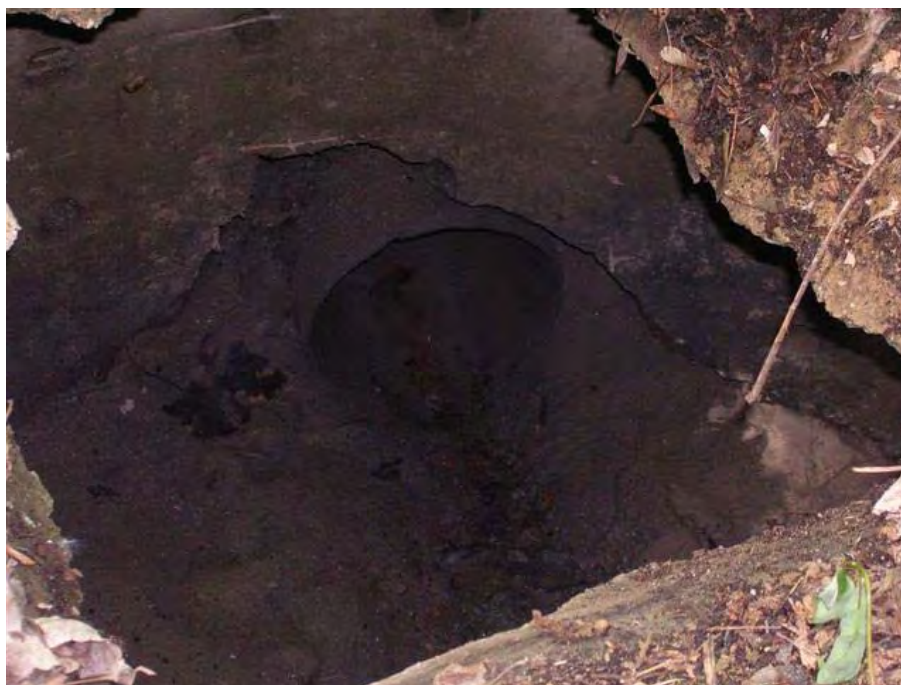
SCENE: View of the interior of the dry well and soil sample location SS-26.

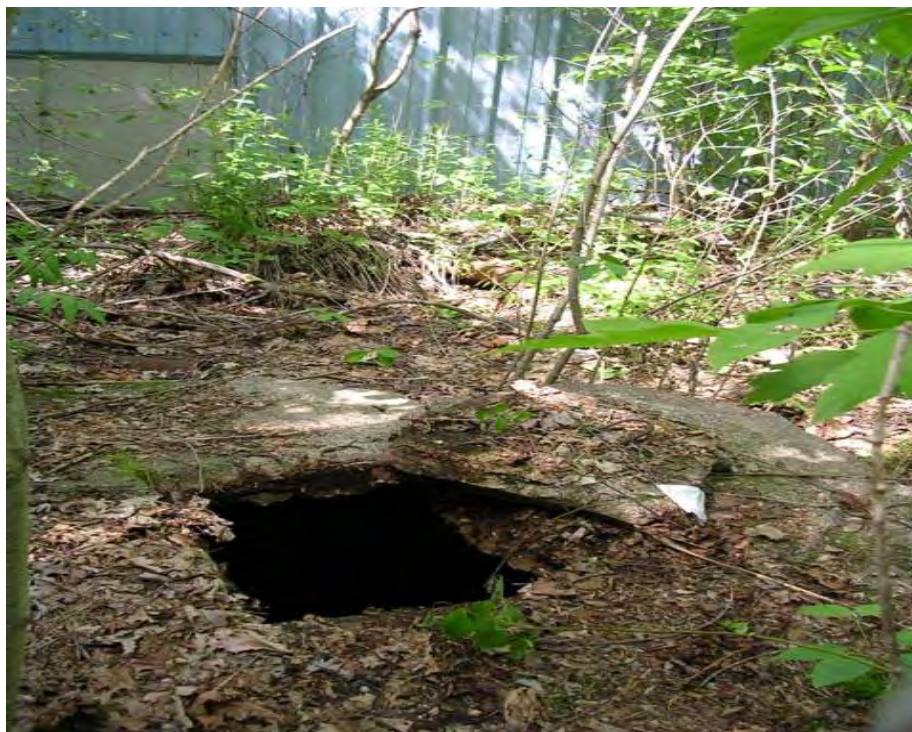
SCENE: View of the dry well and soil sample location SS-26. Photograph taken facing north.

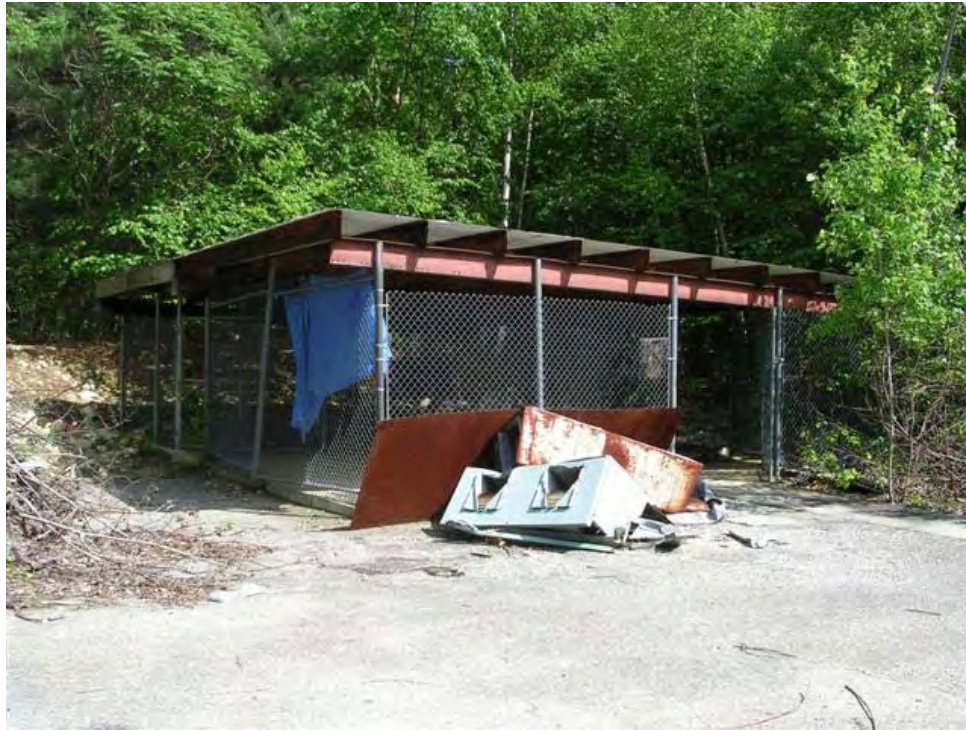
SCENE: View of the drum storage area. Photograph taken facing southeast.

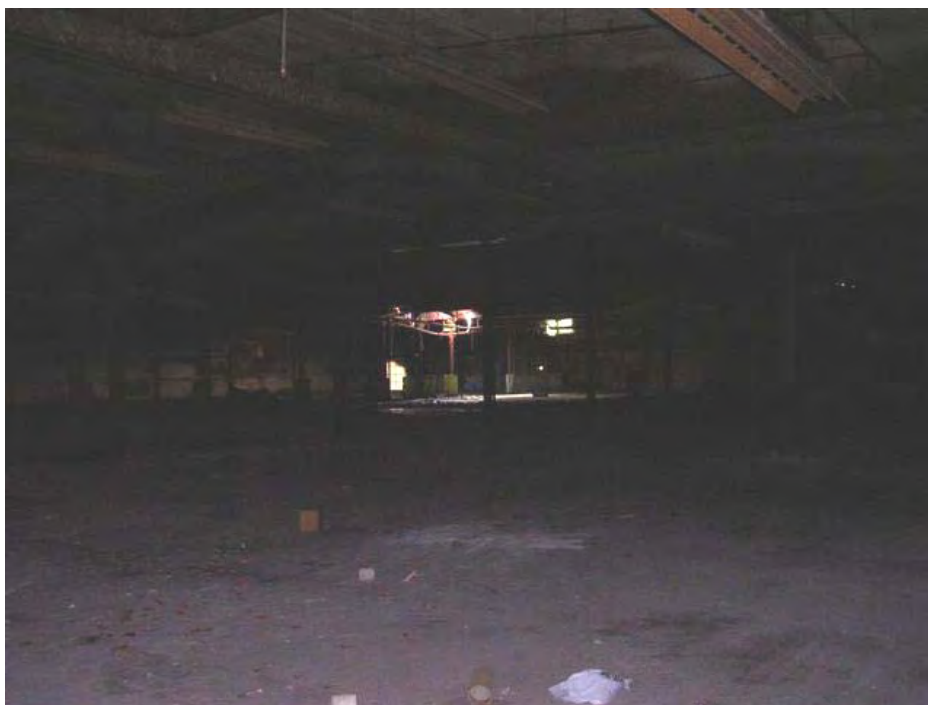
During site activities, START observed that the building was in poor condition, the roof of the Production Area was collapsing, and there was debris located throughout the building.

SCENE: View of the building interior of the Production Area.
